# SAGAMORE HILL HOME OF THEODORE ROOSEVELT

Sagamore Hill National Historic Site  
Oyster Bay, New York

Historic Structure Report

**SAGAMORE HILL  
HOME OF THEODORE ROOSEVELT  
HISTORIC STRUCTURE REPORT**

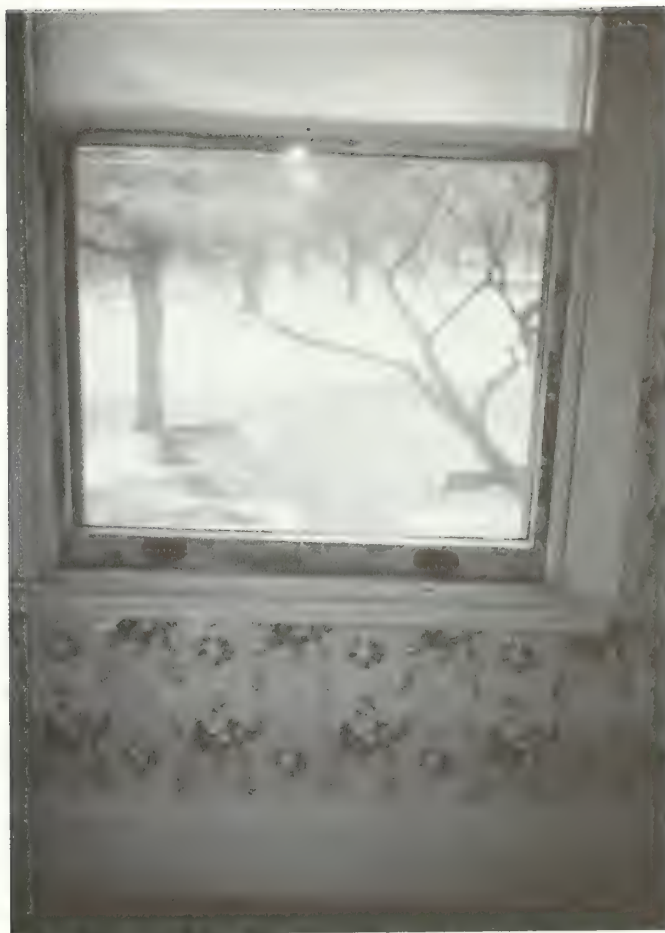
**Typical Window Sash Condition Before Restoration**

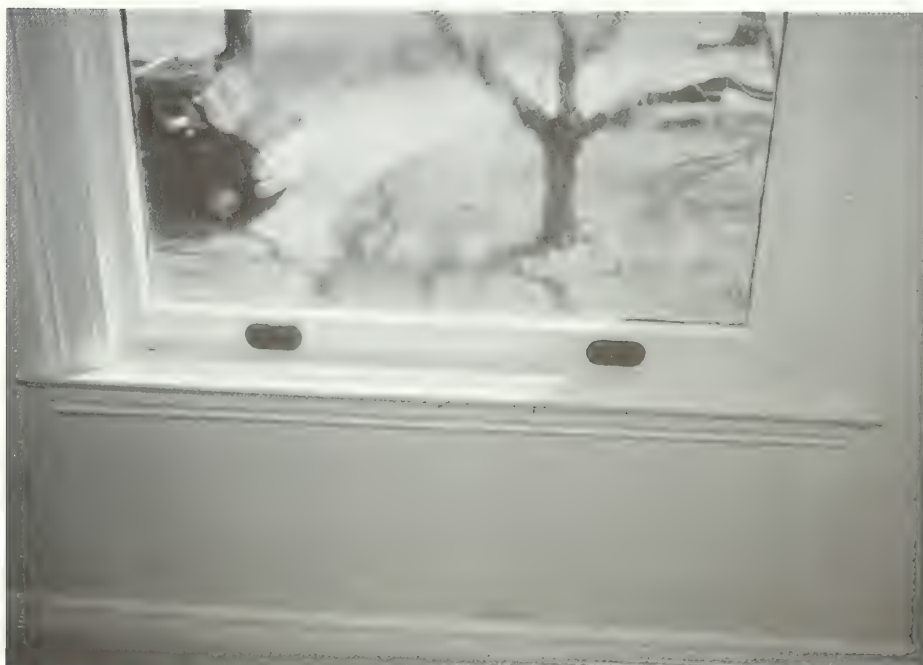
**Typical Window Sash Condition After Restoration**

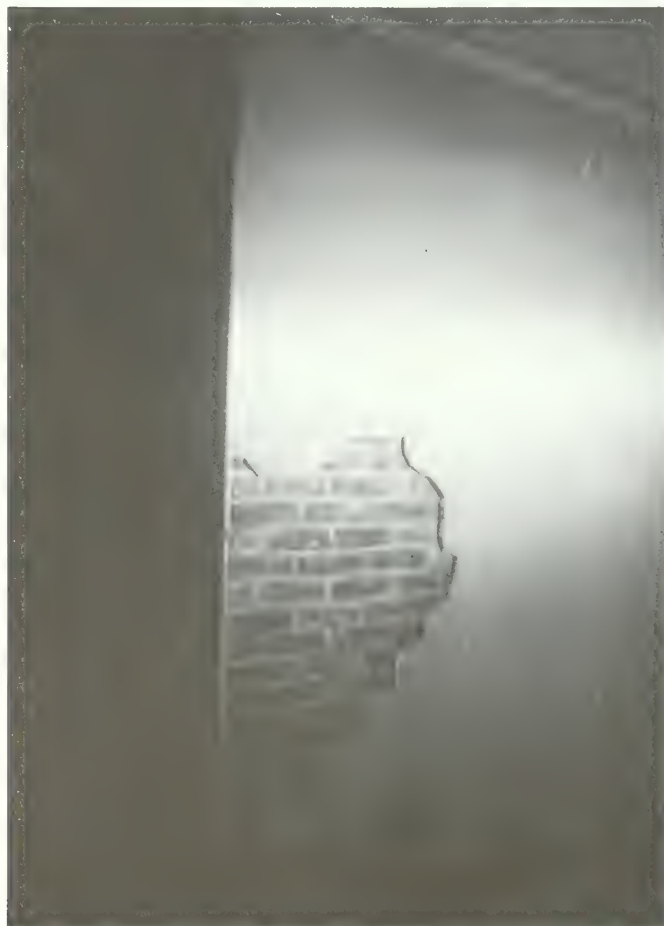
**Alice's Room: Plaster Damage**

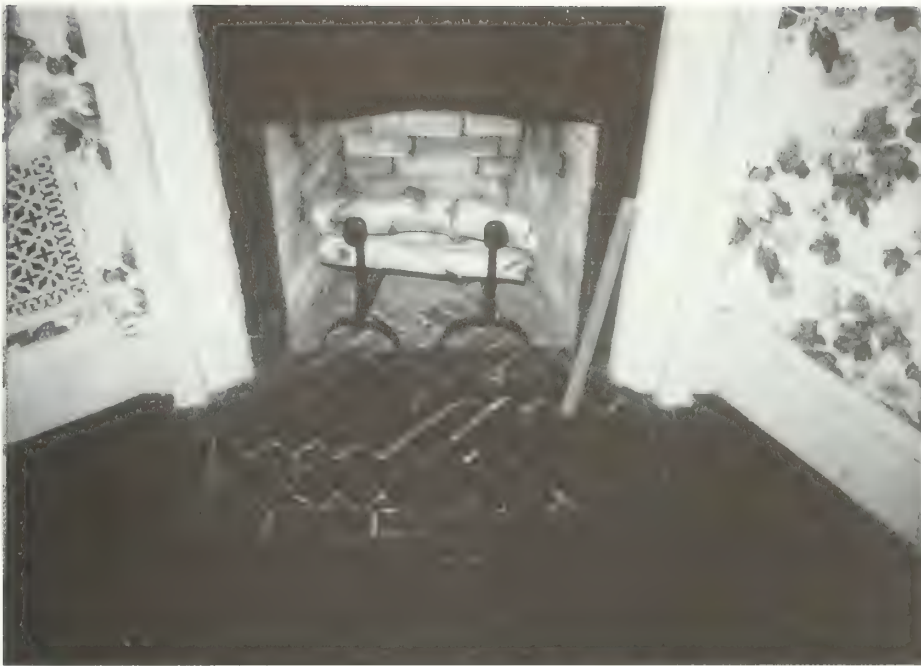
**Mother's Room: Condition of Fireplace Hearth  
Before Restoration**

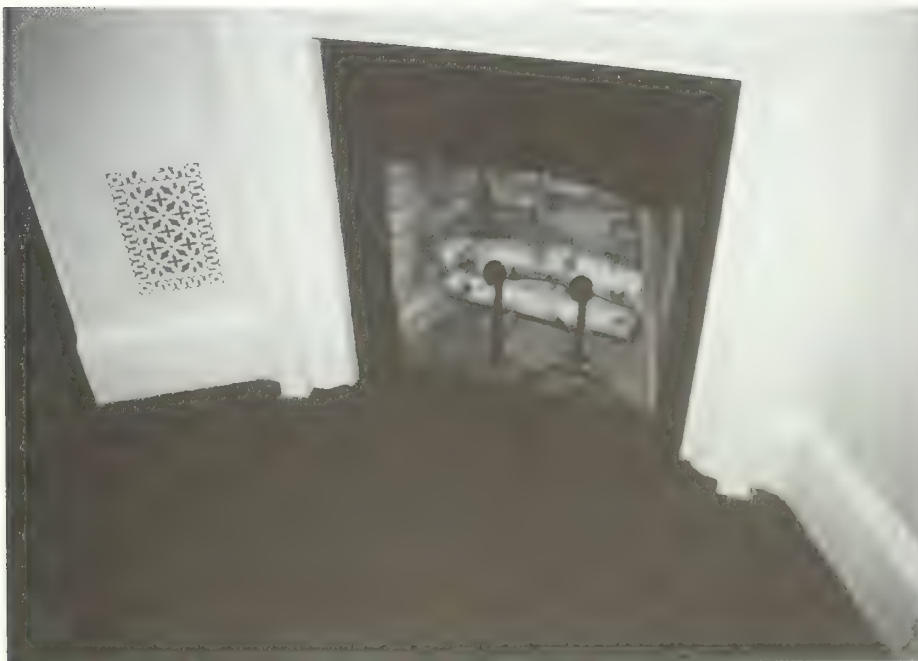
**Mother's Room: Condition of Fireplace Hearth  
After Relaying, Repointing, and Repainting**

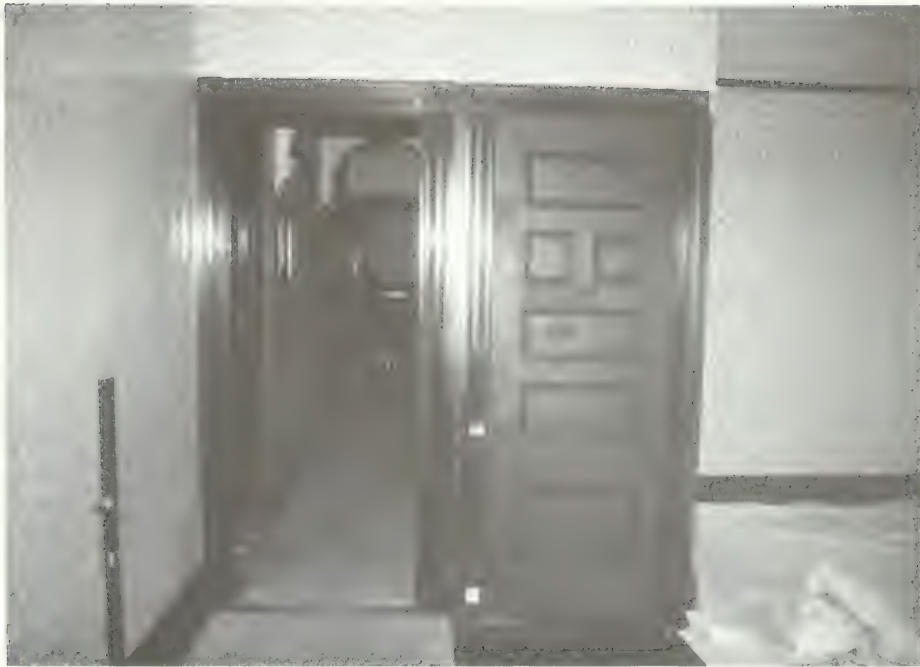
**Typical Condition of Stained Woodwork**

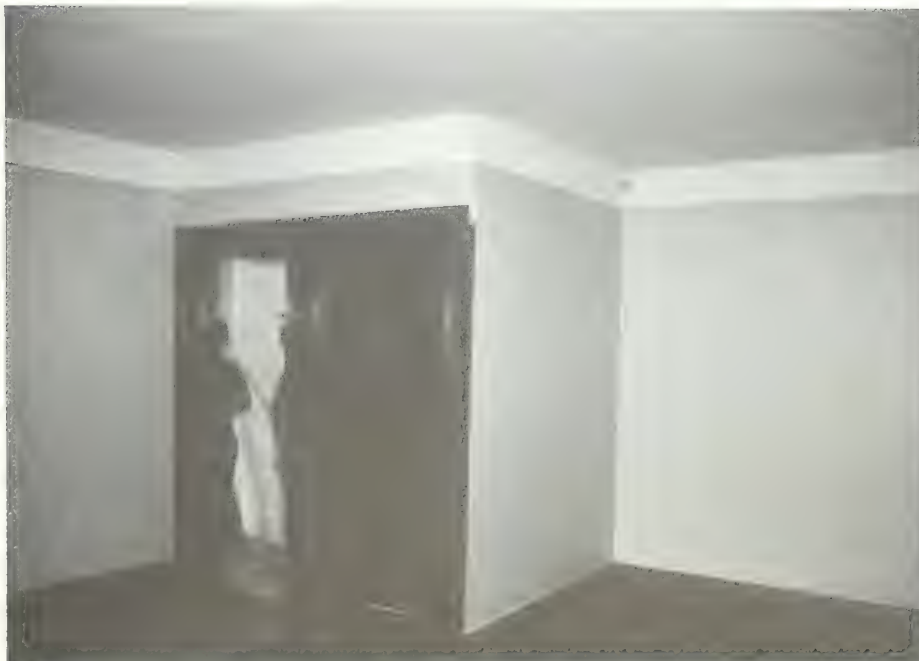
**Typical Refinishing of Stained Woodwork**

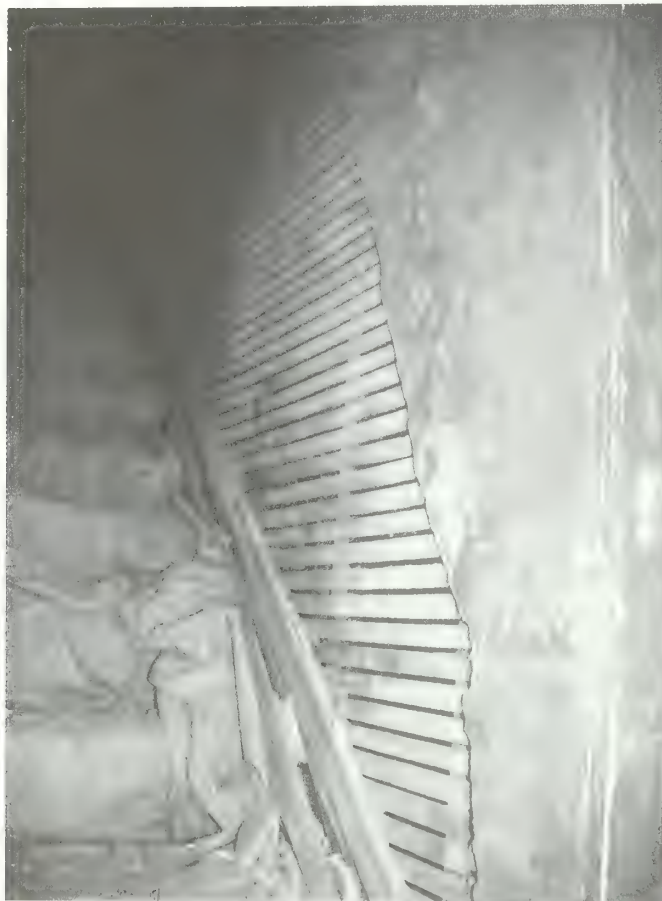
**Second Floor Rear Hall Stairway: During Restoration  
(plaster removed)**
